POLO & ASSOCIATES HOME INSPECTIONS, LLC

*Survey Abstract (*Summary of Concerns*)

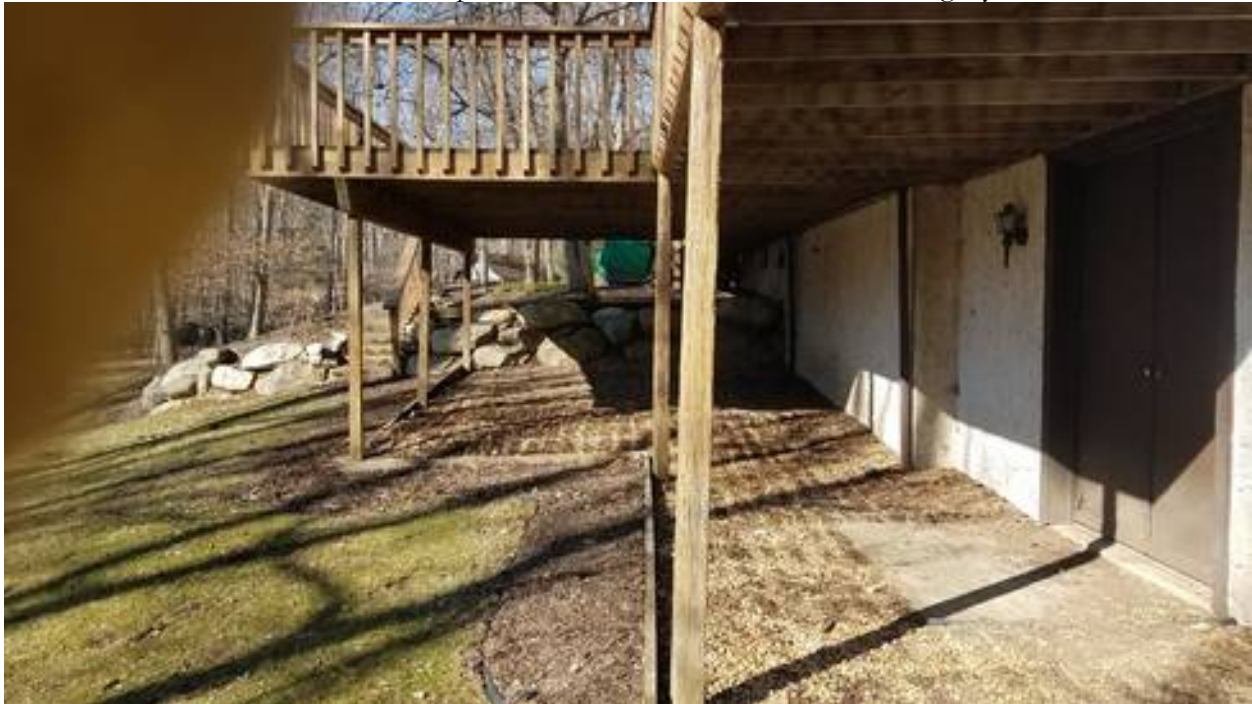
[1C.50](#) Instability/settling indicators & phenomena: typical, (within 1\8") vertical hairline/step cracks: Apply epoxy injection sealant method to cracks on both sides and monitor for continued movement. If cracking persists contact a structural engineer; diagonal cracks in interior walls denotes structural settling; repair wall properly, adjust door if needed and monitor for future movement/cracking; floors uneven/not level; sag/creep likely; sag/settling/shrinkage/partitions offset from structure below likely

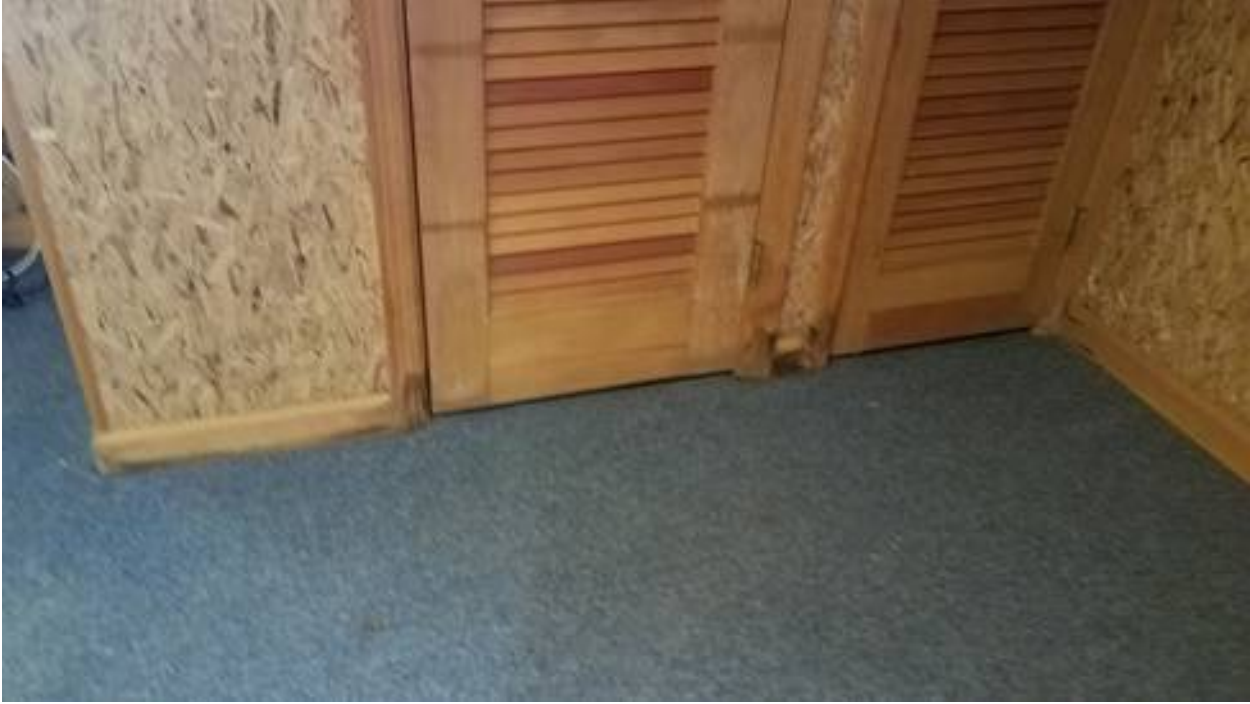
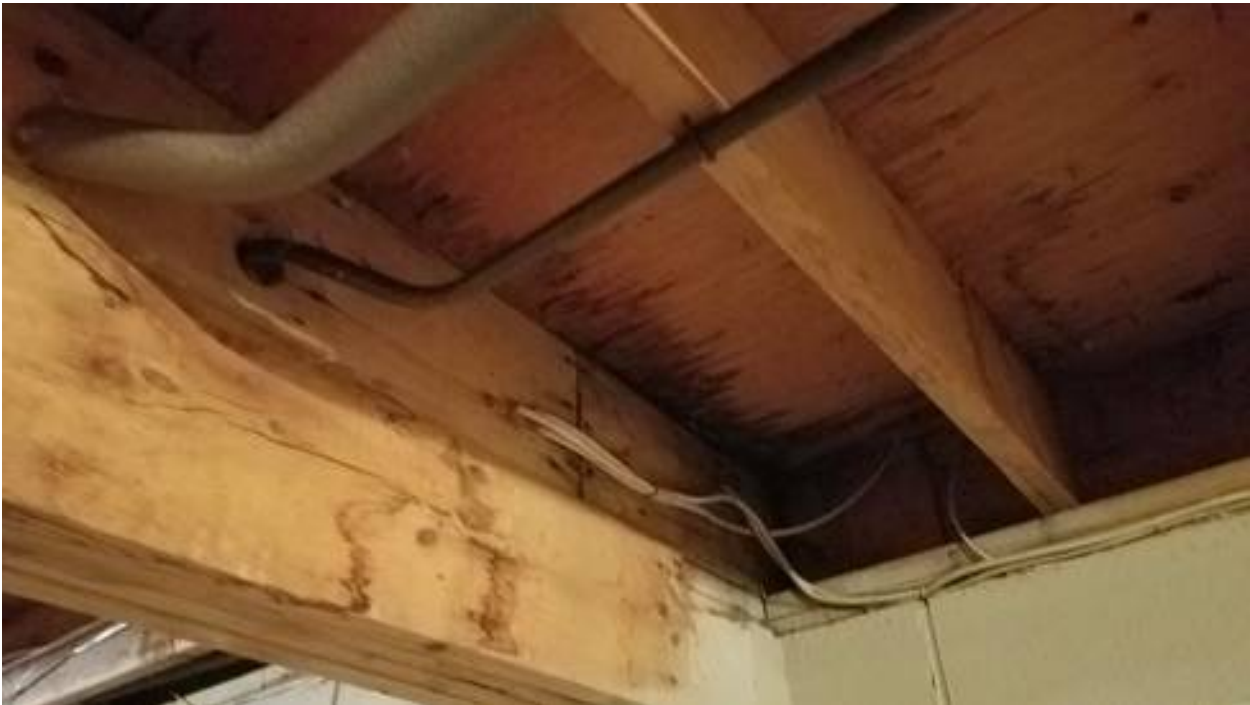
[1C.18](#) Structure/foundation moisture indicators and phenomena: Painted walls/floors may be concealing possible deterioration or chronic water intrusion conditions, termite mud tunnels, etc. Consult sellers as to any moisture/insect issues; water damage found around well equipment and under kitchen area in the basement (consult seller as to why/obtain contractors repair receipt); efflorescence; moisture penetration likely from outside through foundation wall at the front; stains visible in basement

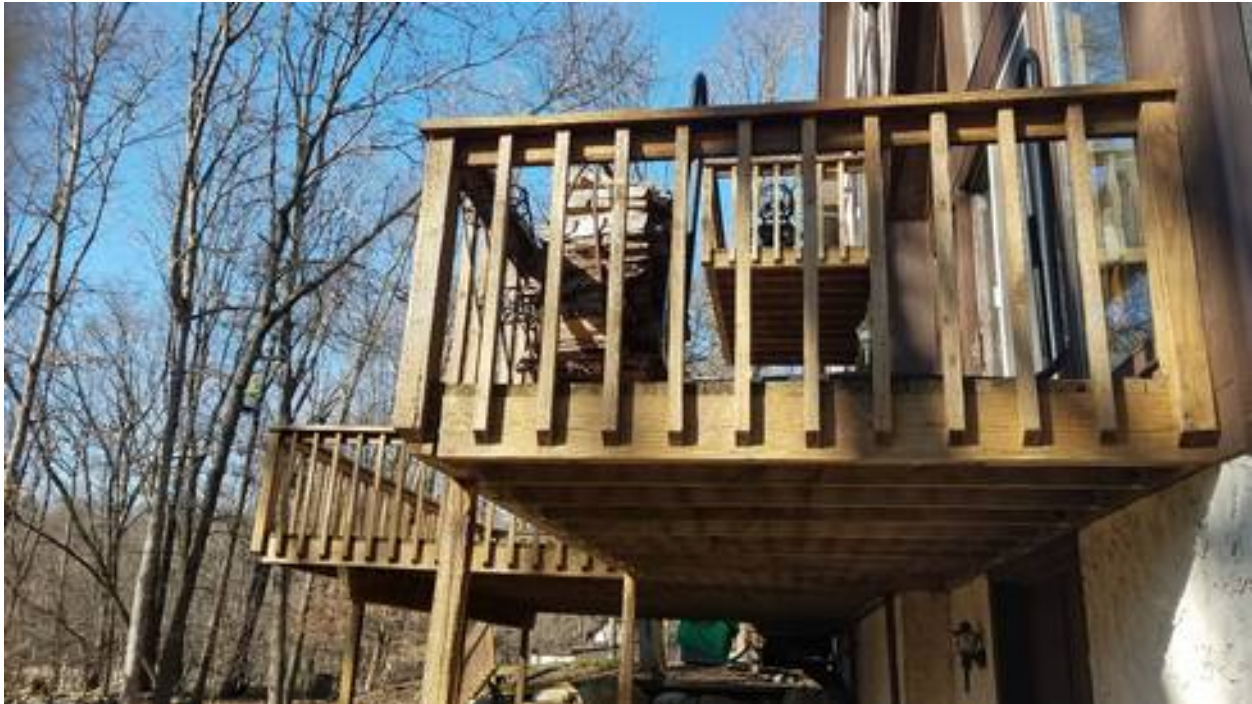
Balusters (all) should be doubled screwed both top and bottom on railings for safety. Repair is recommended

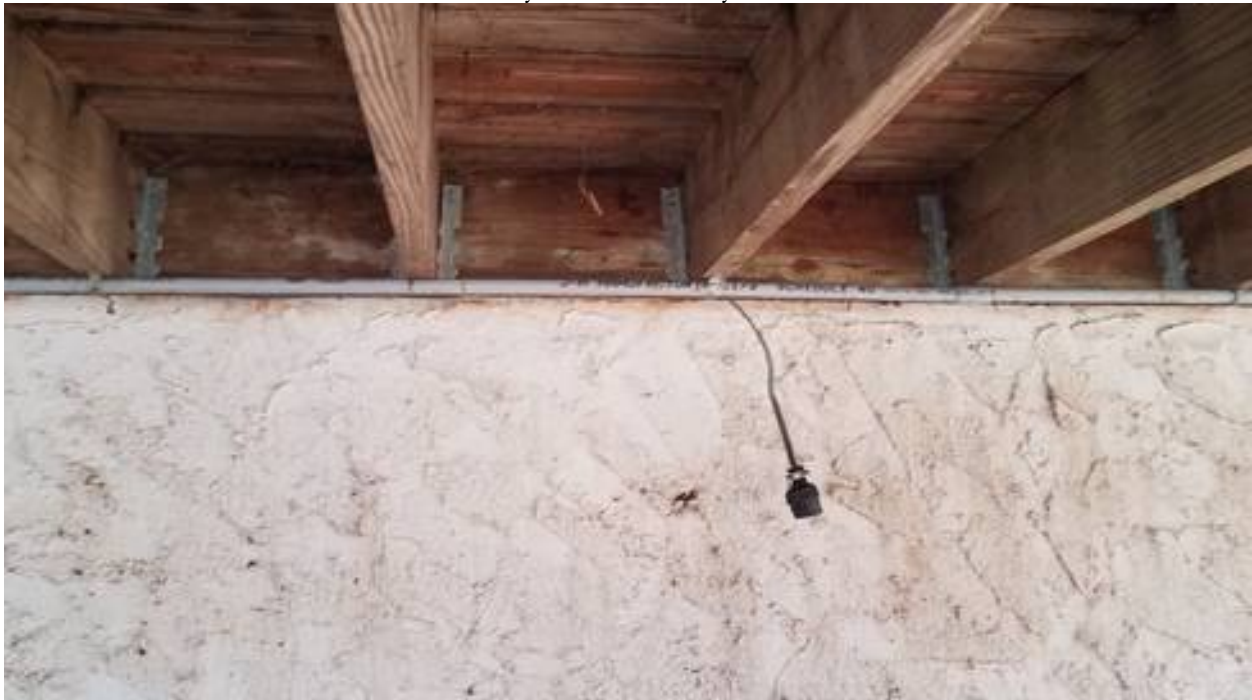
1C.16 Deck/ledger boards' attachments to house is inadequate in areas. Bolt to dwelling every 24" for structural stability. This is a safety concern

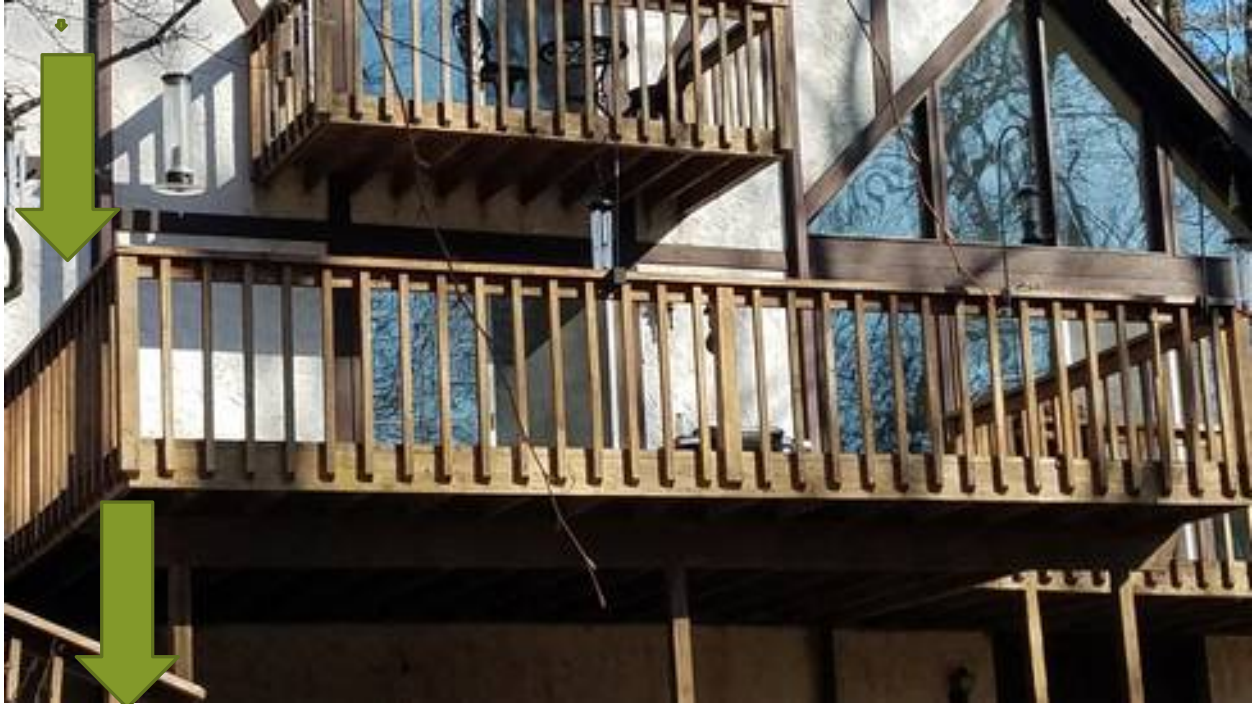
Deck settling/built out of level towards the garage. Column(s) may not have adequate or ample footings. Contact town for permits and repair as needed for structural integrity and safety

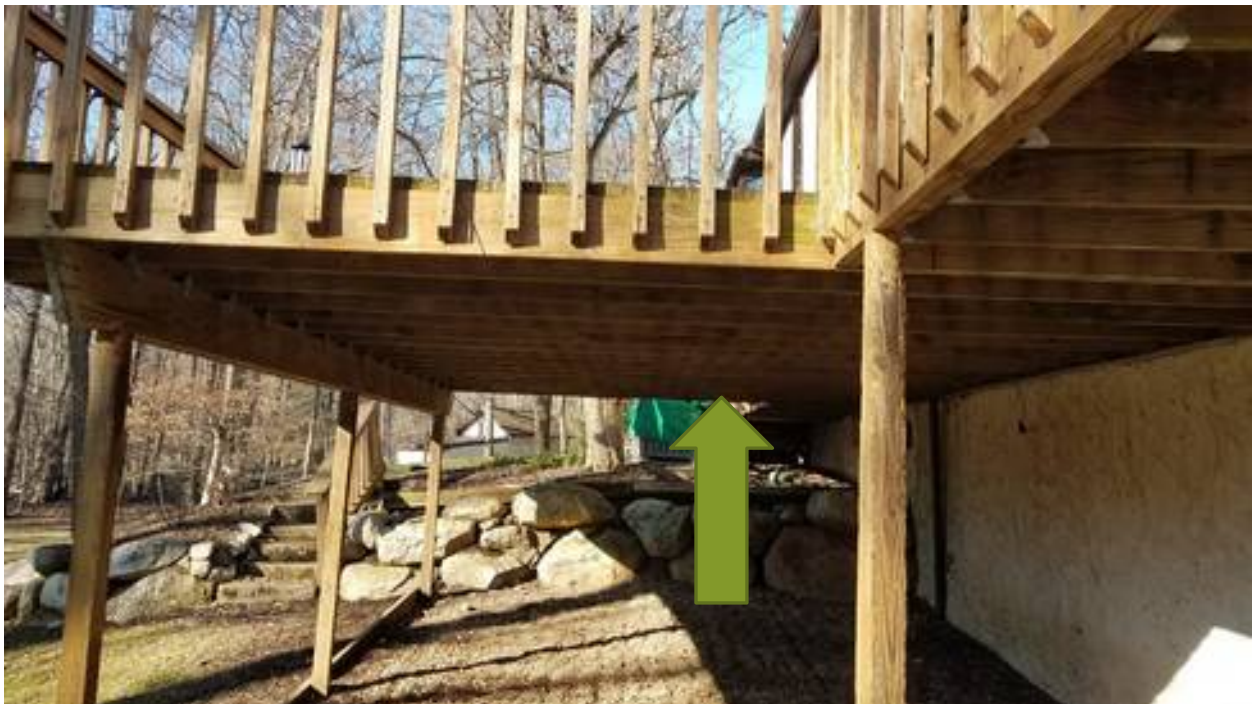
Deck sagging in the center (long span) and beneath guardrail (near stairs). Add bridging at center span. Repair is recommended for structural integrity. This is a safety concern

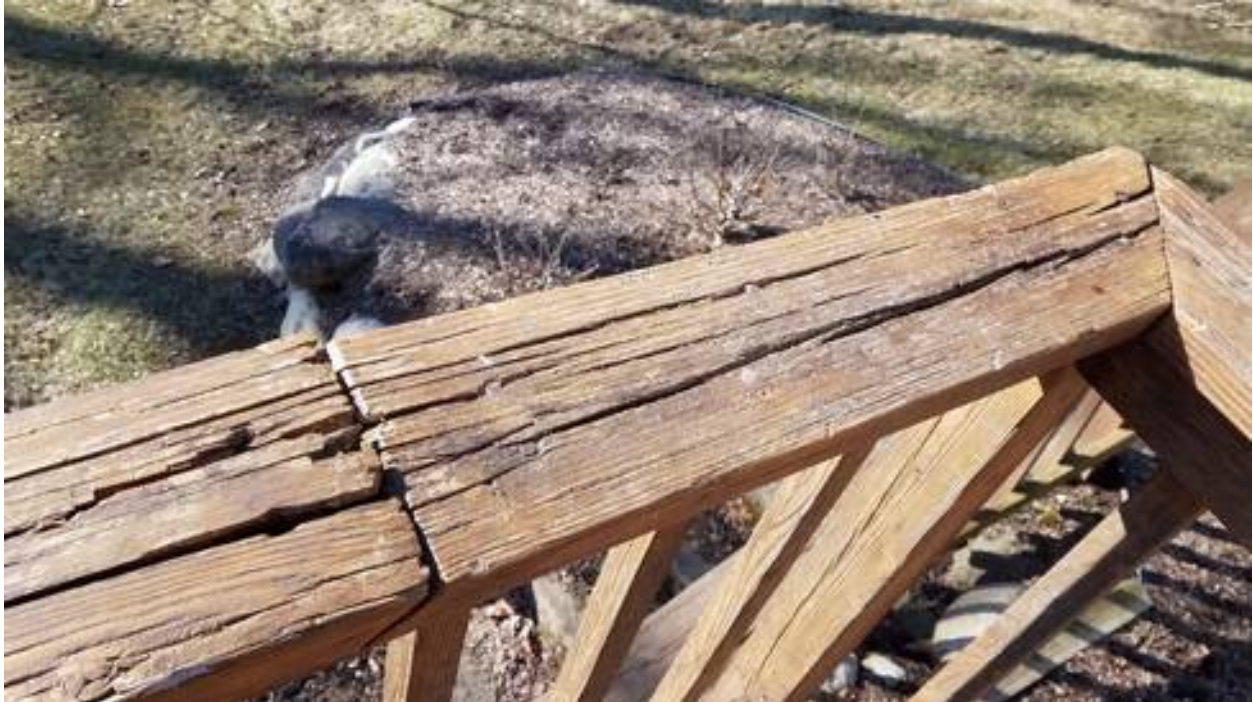
[1C.07](#) Decking/guardrails: Wood is deteriorating/splintering/splitting in areas. Recommendation: Replace as needed. This is a safety concern

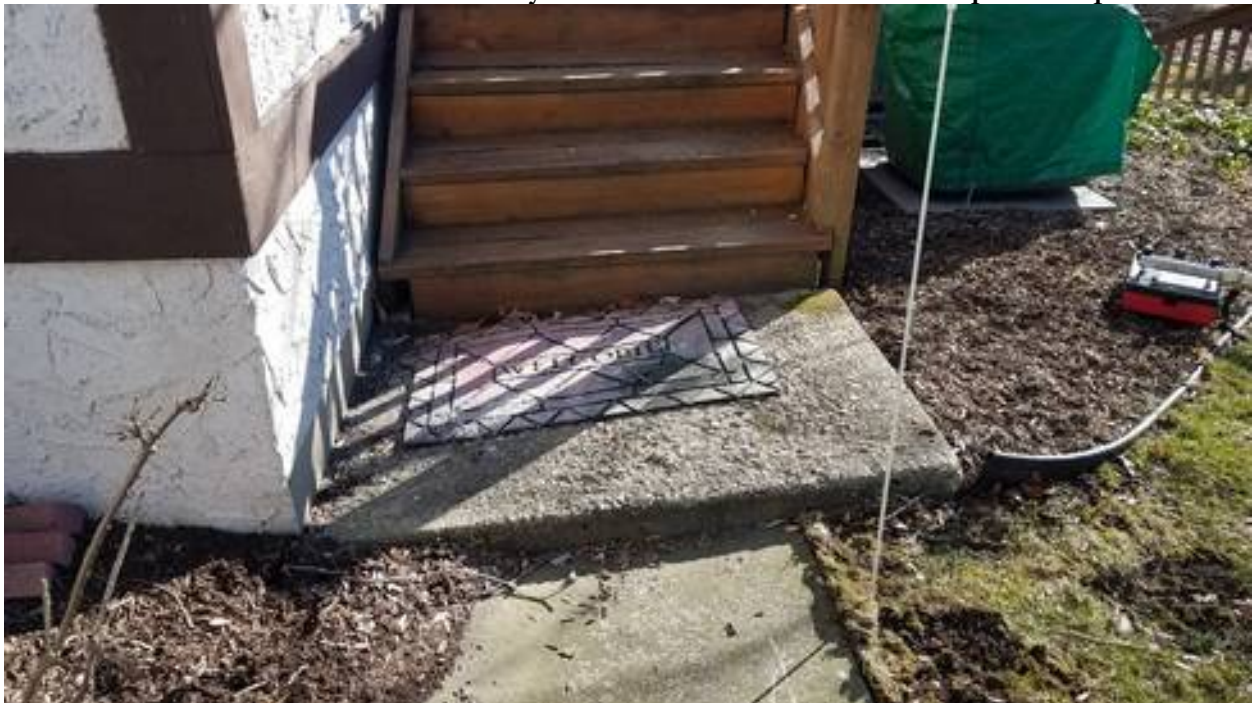
[1S.16](#) Slabs possible trip hazards, settling, pitched to home on the right side and at the rear. This is a safety concern. Recommendation: Repair or replace

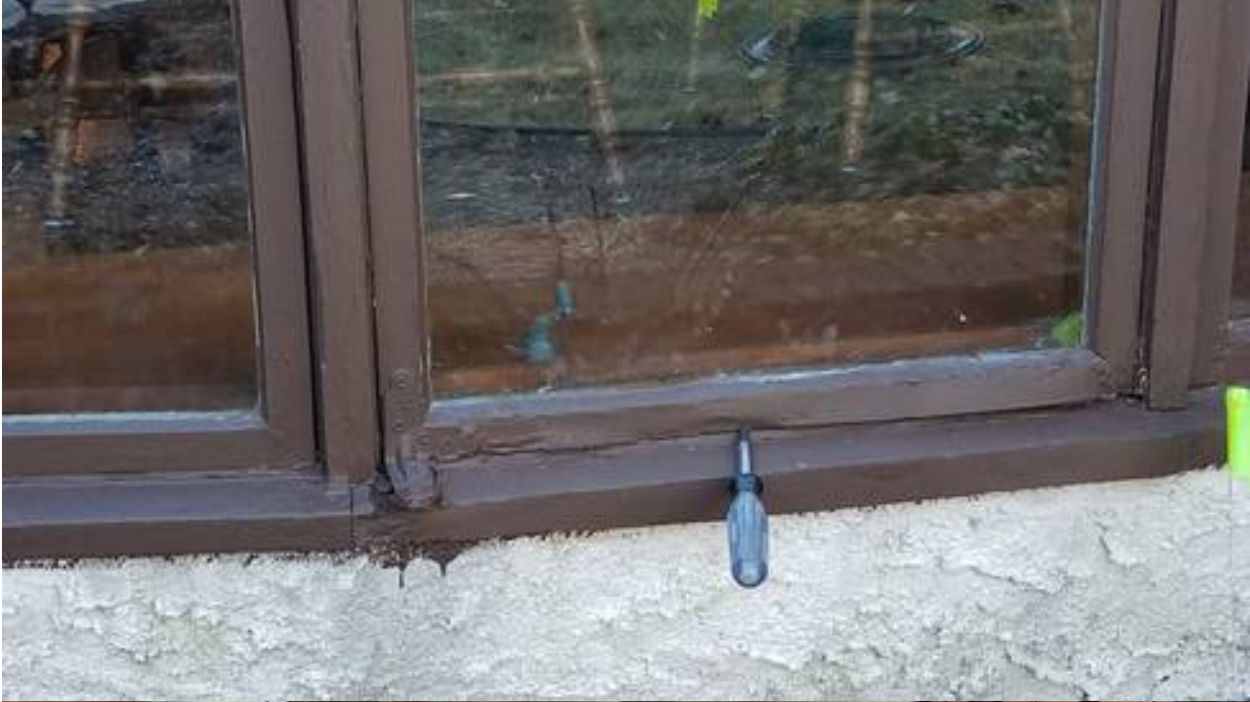
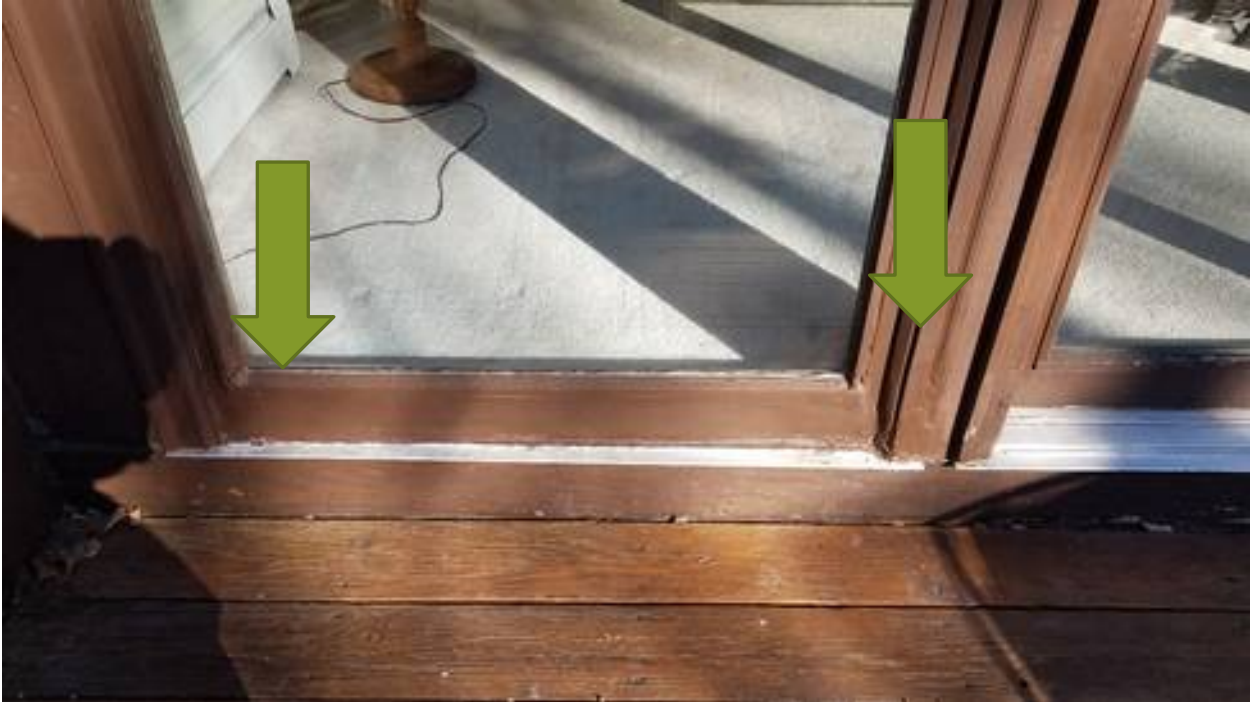
1C.06 Windows/slider rotting in areas. Recommendation: Replace. This is a safety concern. This is an expense concern

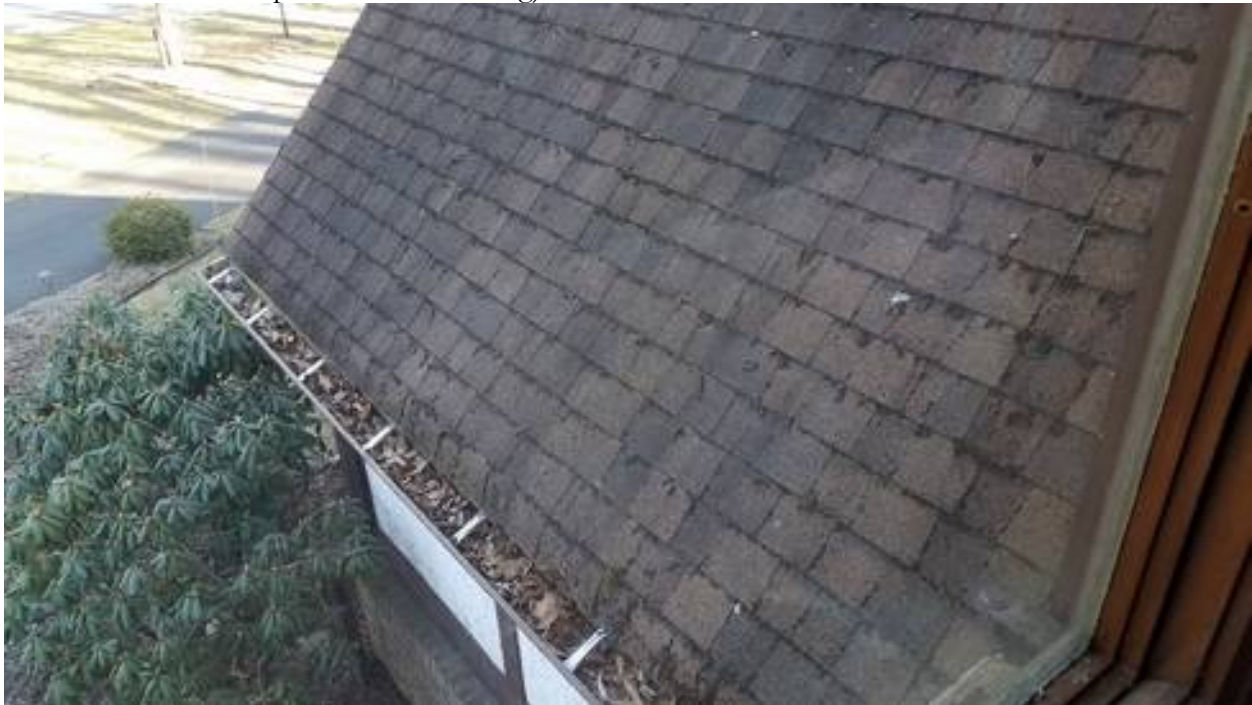
Leaves, seeds/water in gutters; service now and periodically to prevent water intrusion, ice dams, mold, rot, insect damage, etc. The addition of a permanent, professional gutter guard system is recommended to control excessive gutter debris and minimize maintenance (but only if soffits are properly ventilated in order to prevent ice damming)

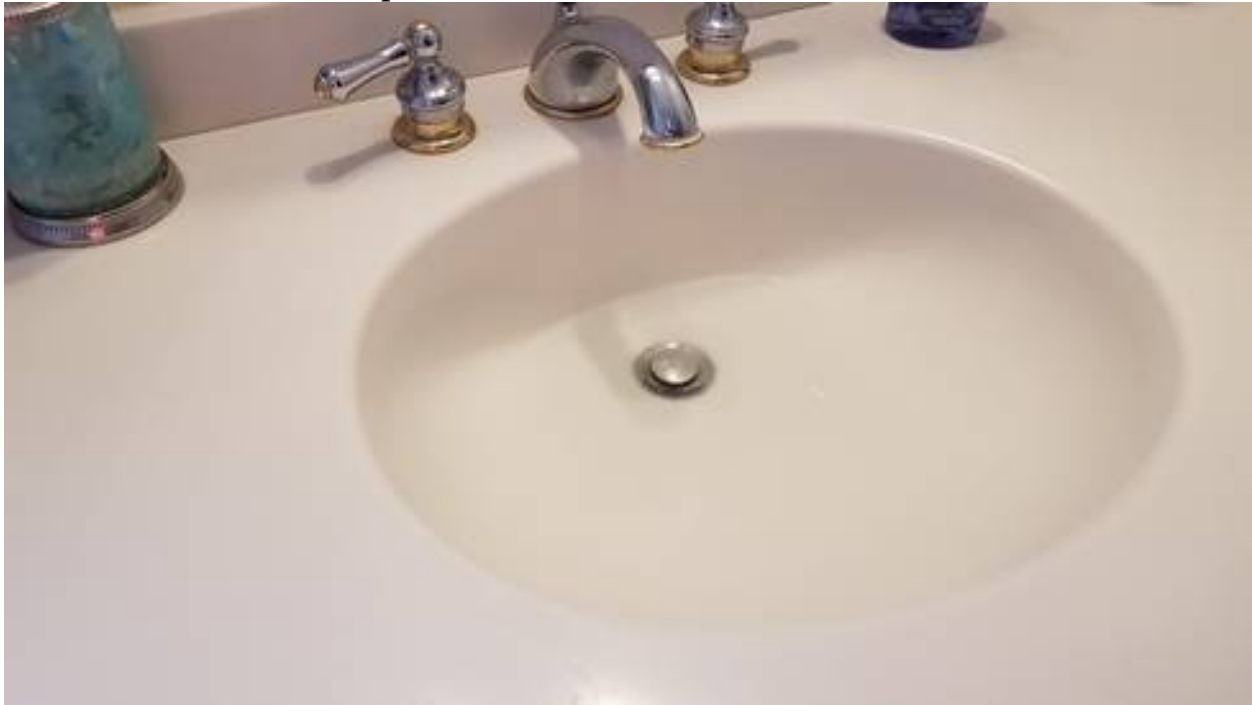
4C.05 Drain does not properly drain: sluggish in the upstairs bathroom sink on the right side. Repair is recommended

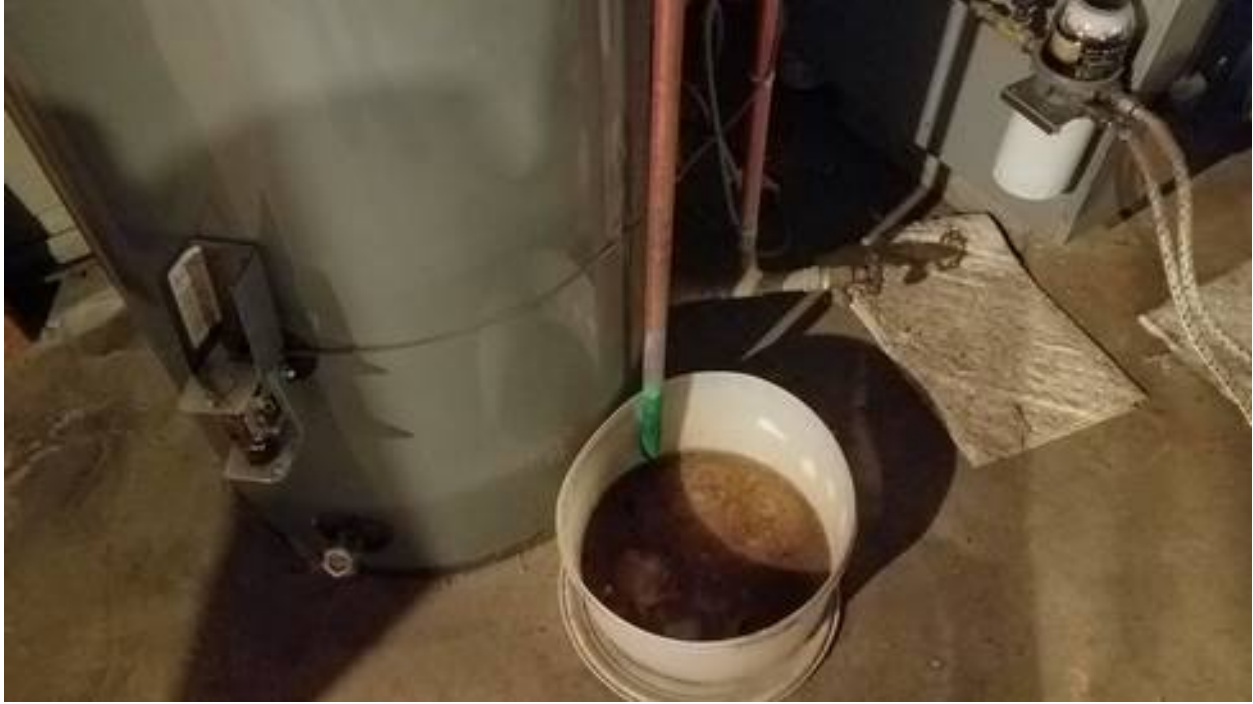
4C.02 TPR valve discharging from water heater (at least 210 degrees?). Immediate evaluation by a licensed plumber is recommended. This is a safety concern

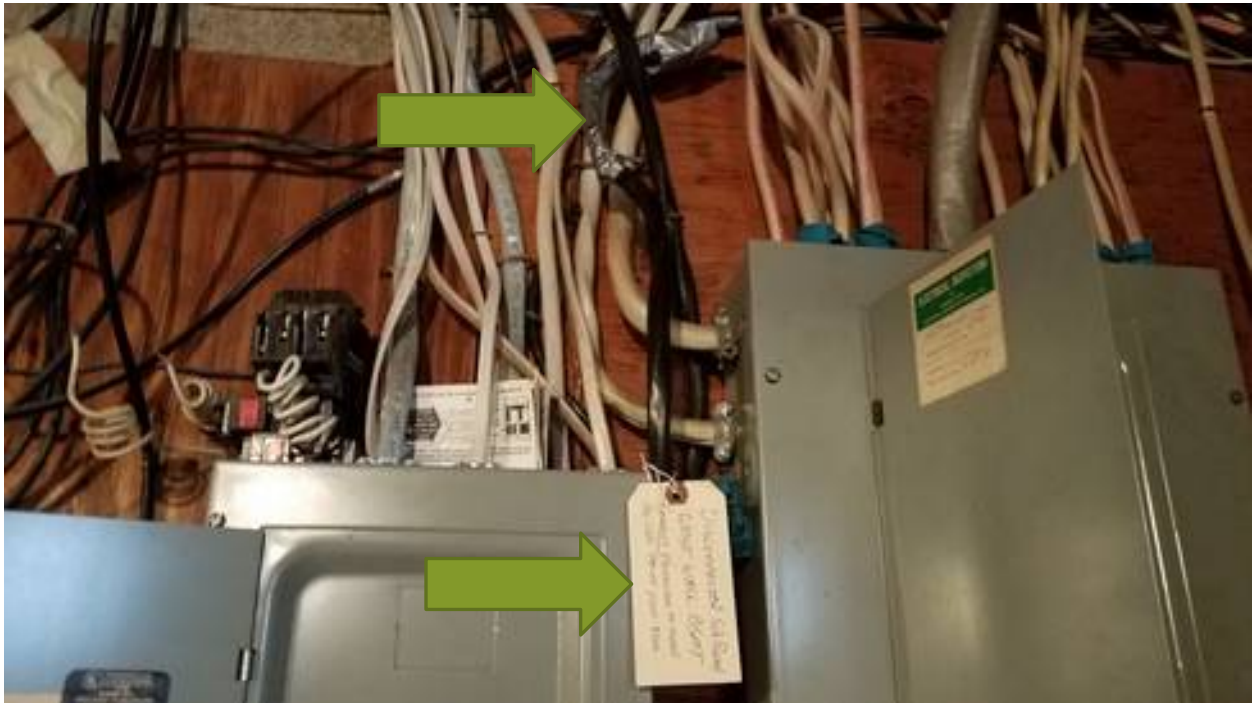
- [5C.67](#) Labels and an accurate is legend recommended for ALL panel/sub-panel box circuits. This is a safety concern
- [5C.46](#) Sub-Feeder panel box grounds & neutrals are not separated and should be for proper function and safety
- [5C.19](#) Dedicated circuits are always recommended (and cannot be confirmed) for major appliances such as refrigerator, dishwasher, or anything that produces heat. Repair as needed for safety and proper function
- [5C.11](#) Many circuit breakers/sub panel found in "off" position not fully wired/taped up wires are not turned on therefore cannot be assessed. This is a safety concern (repair/assess off breakers/circuits prior to sale). Evaluation by an electrician is recommended for all "off" unfinished electrical

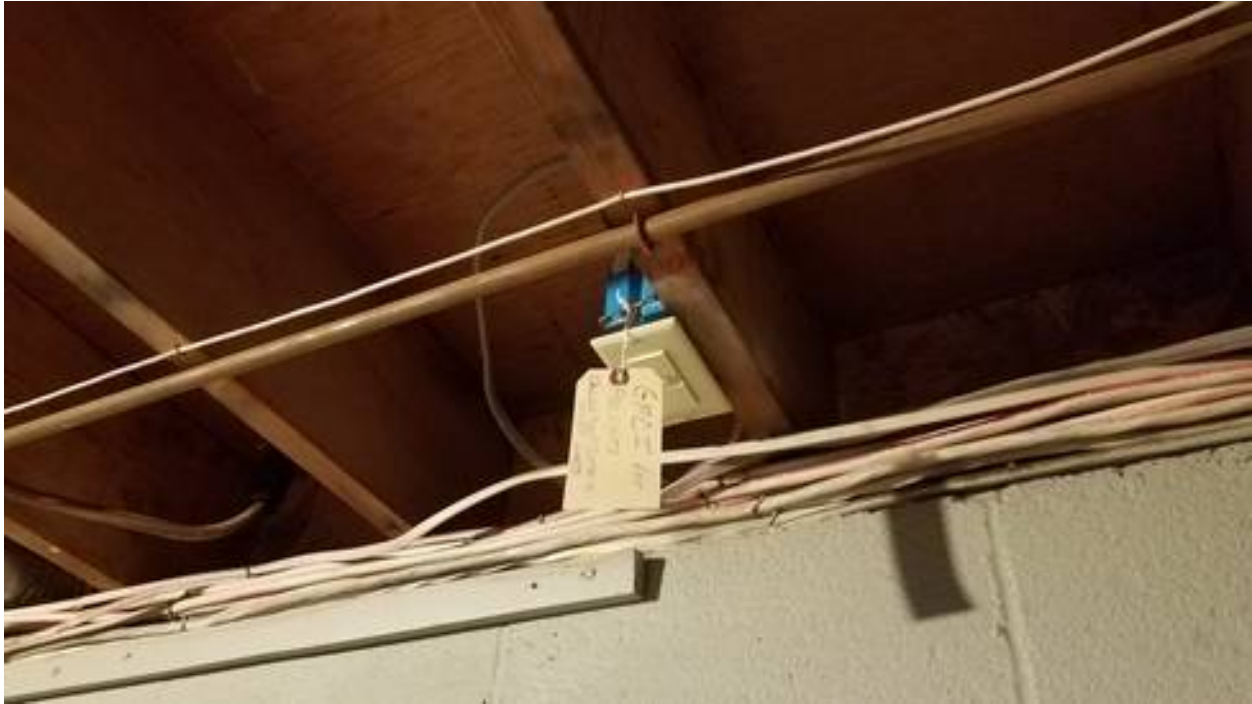
**GFI not able to be reset, "line" and "load" may be reversed in the basement ceiling.
Recommendation: Repair. This is a safety concern**

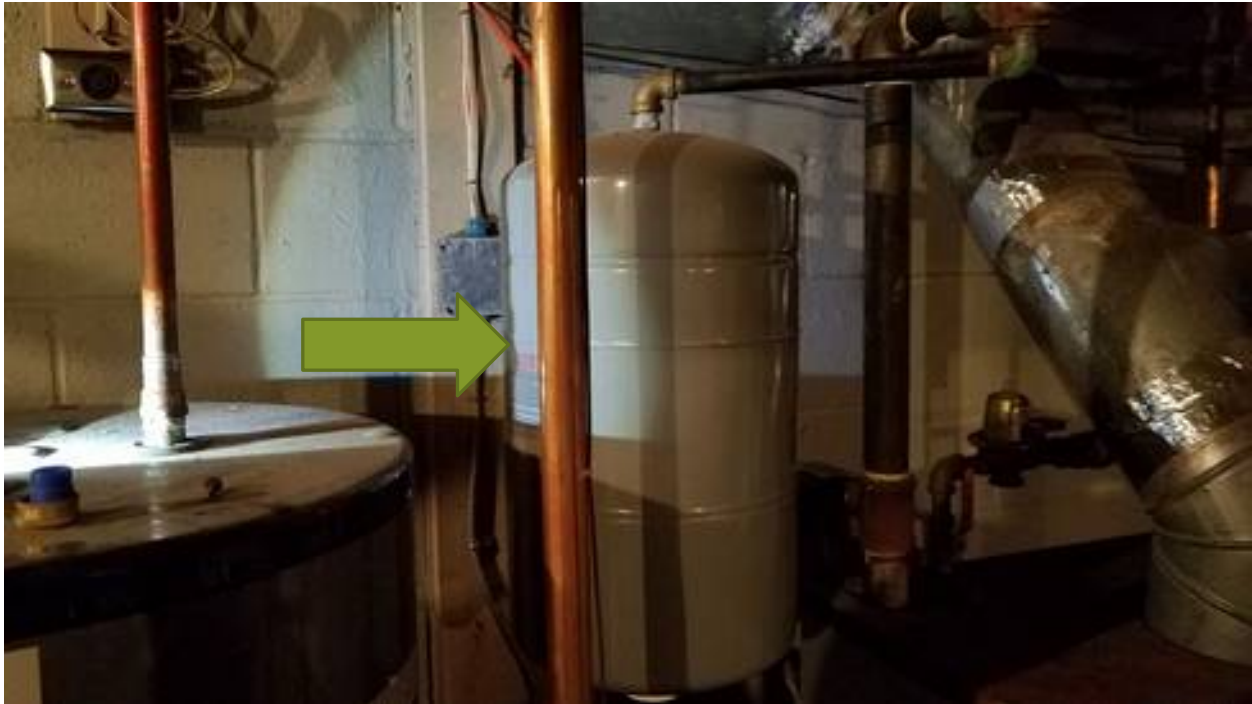
Boiler expansion tank appears water logged and pressure is high. Replacement is recommended ASAP

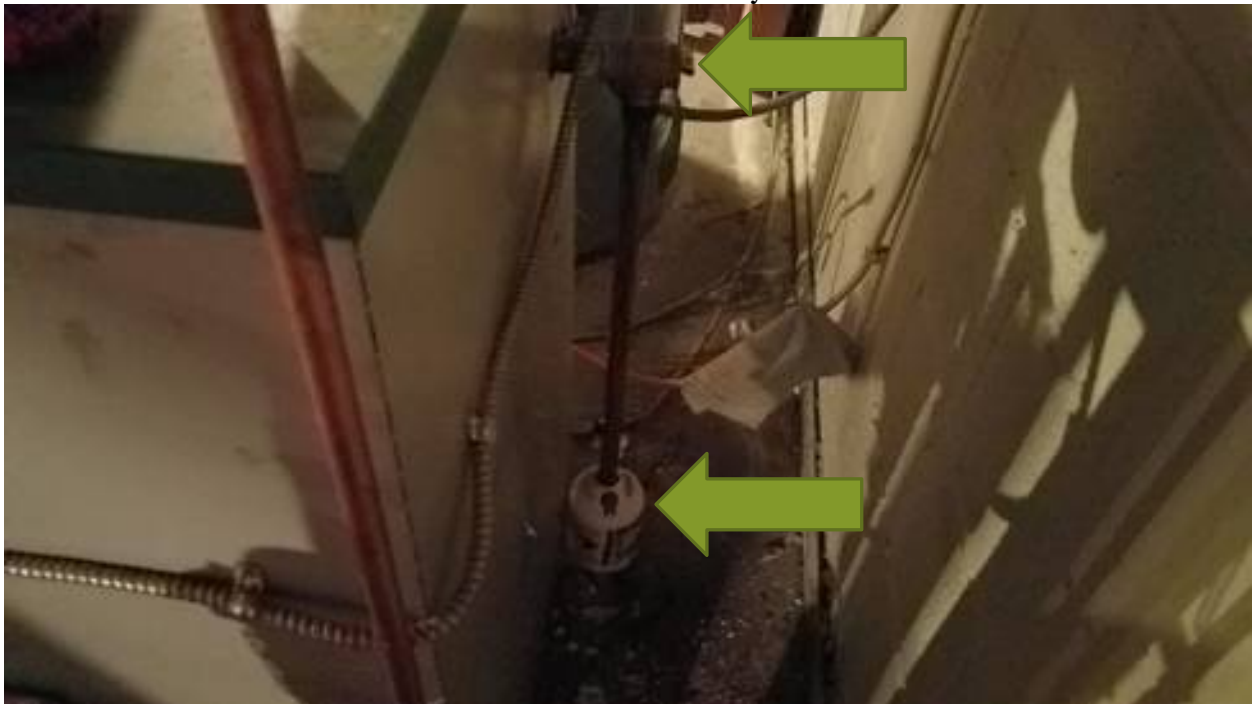
Pressure relief valve is discharging on boiler. Immediate evaluation by a heating contractor is needed. This is a safety concern

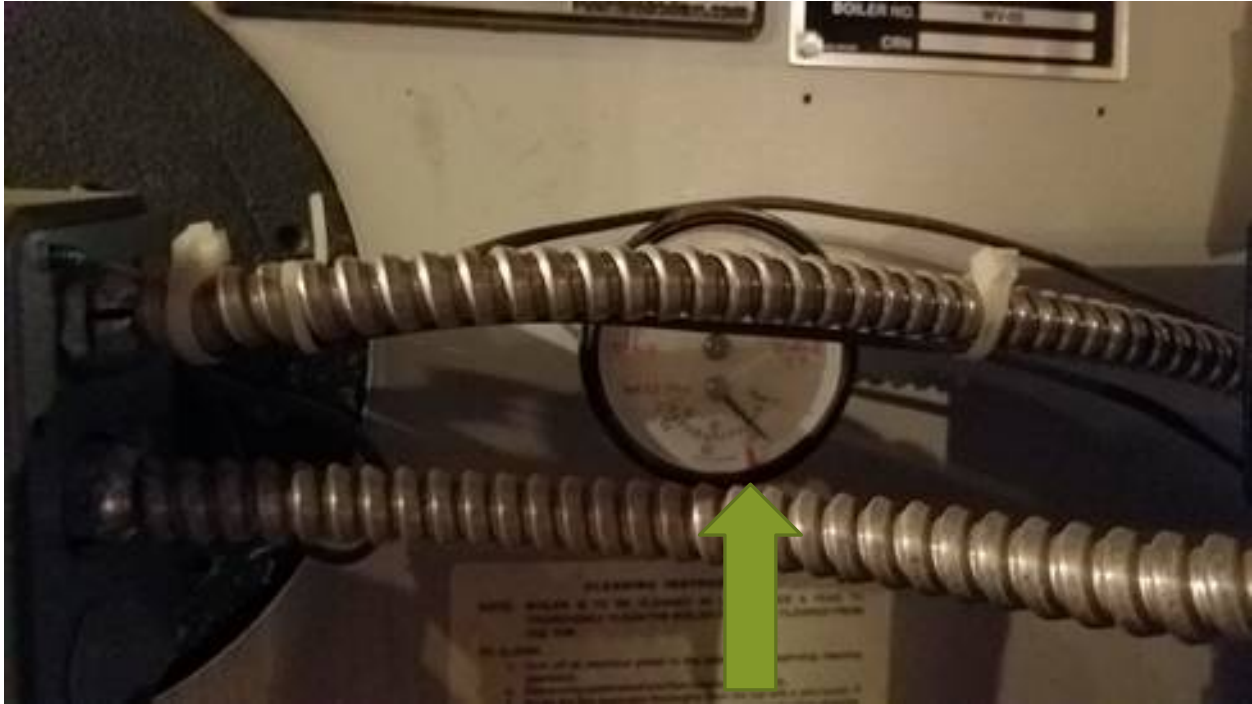
[6C.44](#) Water pressure way too high for boiler (over 50#/sq.") . This is an immediate safety concern. Evaluation by a heating contractor is needed

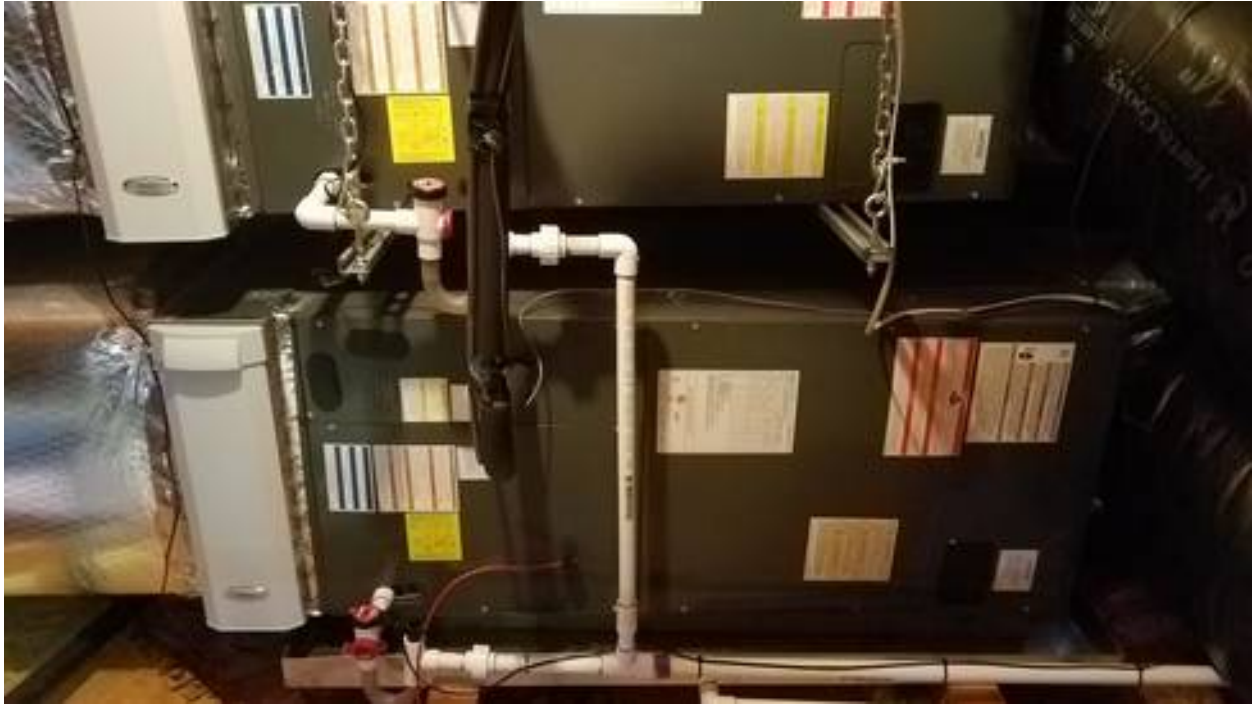
[6C.06](#) Drip trays recommended for condensate systems in the basement and upper unit in the attic
Main and auxiliary condensate lines must be separated to prevent clogging/water damage for proper function in the attic

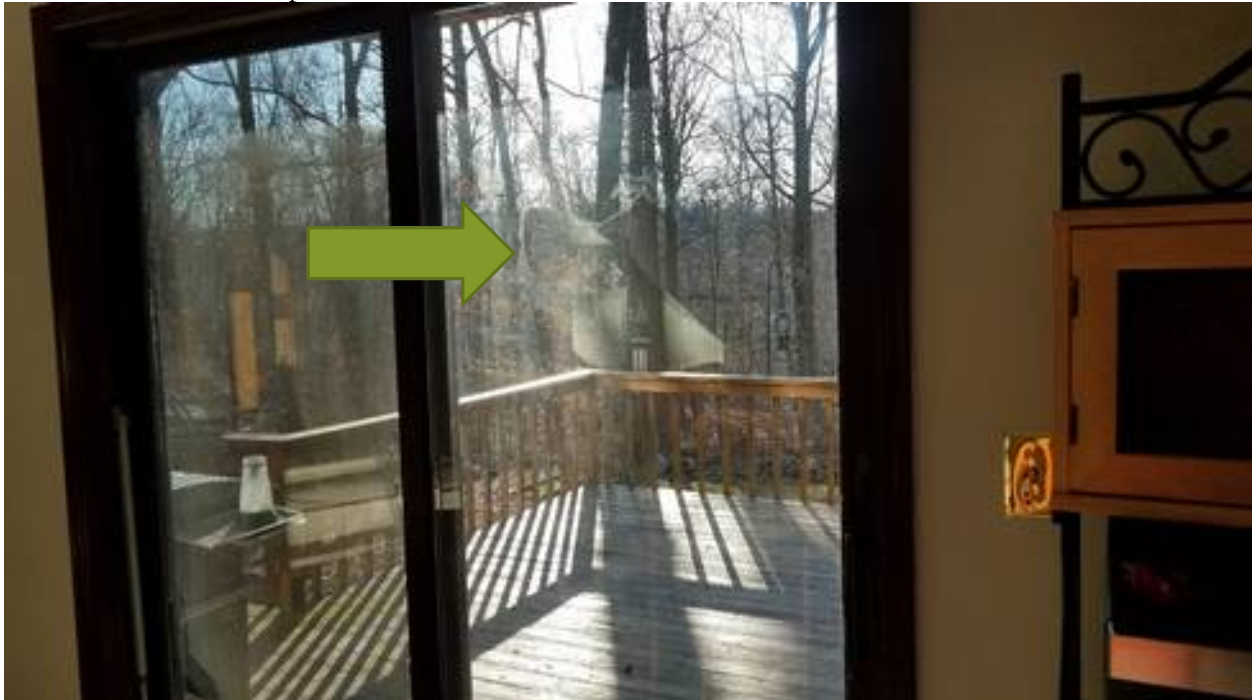
[7C.17](#) Seals cracked (saturated desiccant strip?) on thermal insulating glass is allowing moisture between glass. Replace for proper function for rear sliders in the kitchen and upstairs

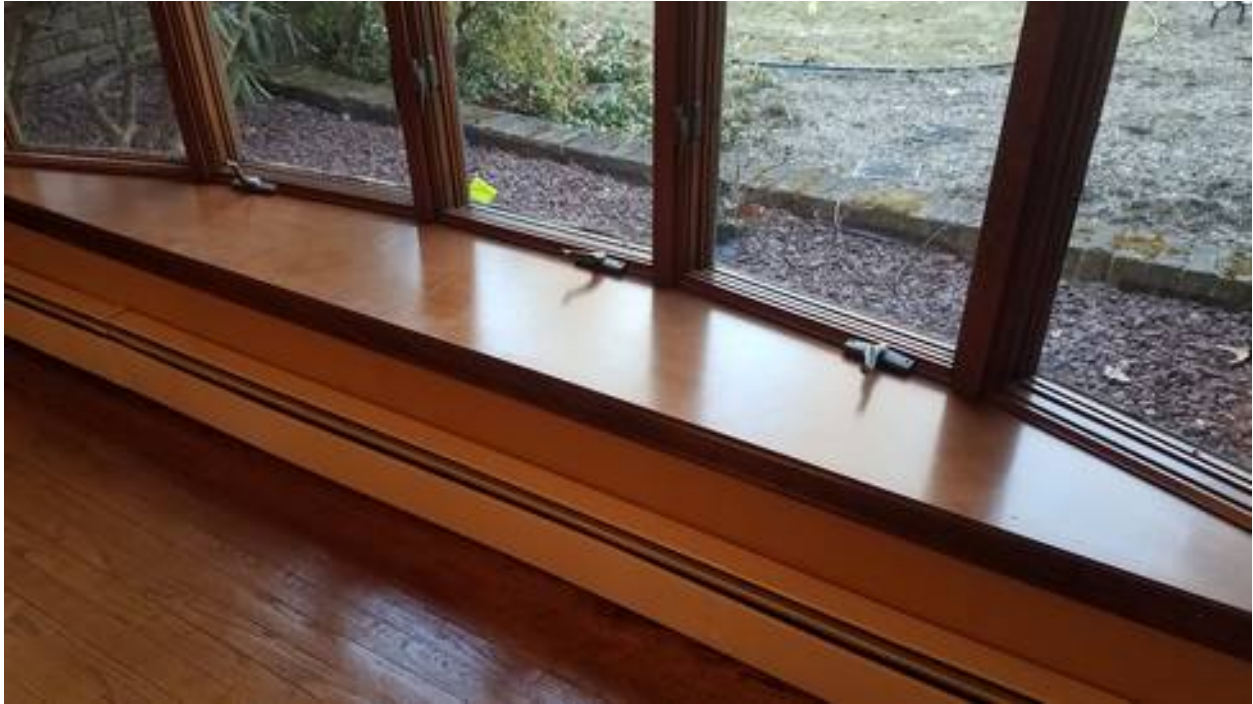
[1C.54](#) Angle bay/bow windows pitched/tipping out and may not be properly supported to structure especially at the front. Repair is recommended. This is a safety concern

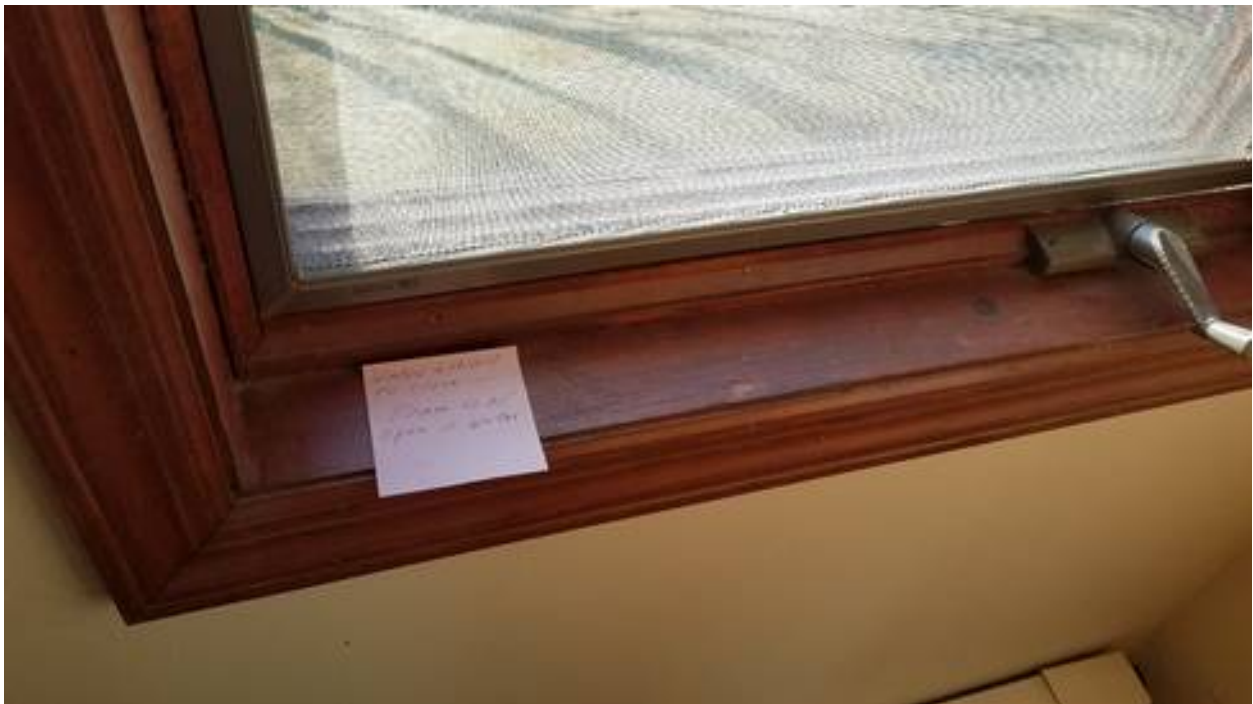
[7C.17](#) Stuck/binding original, wooden, casement windows. Repair is recommended as needed here and there
