POLO & ASSOCIATES HOME INSPECTIONS, LLC

*Survey Abstract (*Summary of Concerns*)

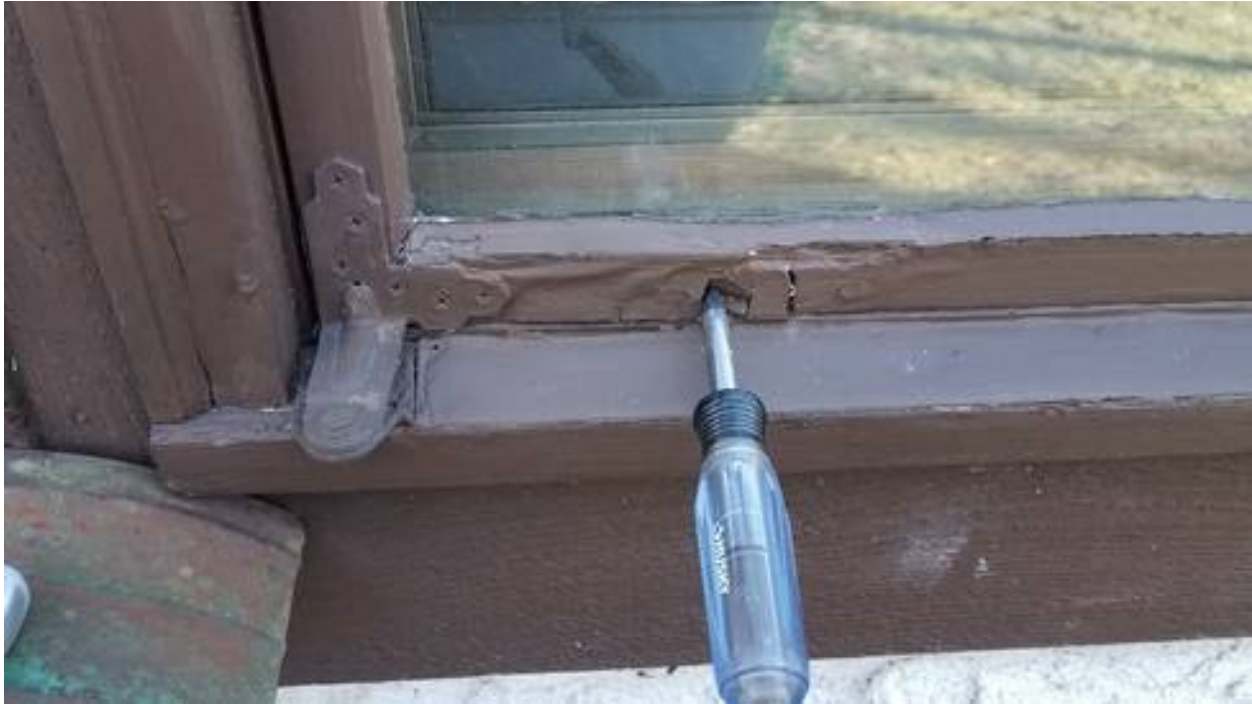
[1C.41](#) Cellulose (wood pile) near house (may attract termites). Remove and assess

[2C.10](#) Wood: "First" wood untreated, too close to earth (8" or less) is prone to rot carpenter ant and especially termite damage as discussed. Repair/treatment is recommended to deter/stop termite activity

[1C.06](#) Wood rot (filled, caulked, painted over, etc.), trim components, windows, sliders, basement doors, etc. Recommendation: Repair or replace
